PRELIMINARY REPORT

SHIAWASSEE COUNTY JAIL

Facility Study

January, 2018

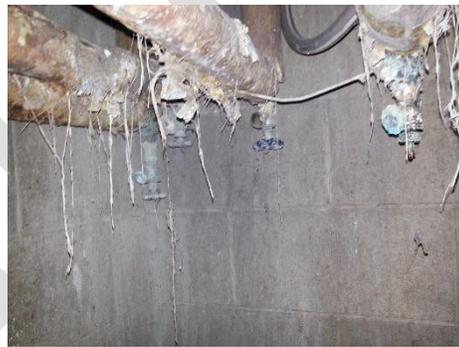
The piping tunnel is a dirt floor with signs of moisture from the ground and dripping moisture from above. The tunnel allows access to the mechanical and electrical room.

The top picture shows the access tunnel (domestic hot and cold water, gas, electrical) below portions of the jail. The space has a sand floor with signs of moisture on the walls.

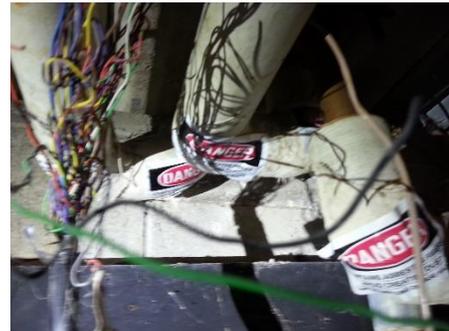
The lower picture shows the deteriorating insulation, piping and wiring in the tunnel.

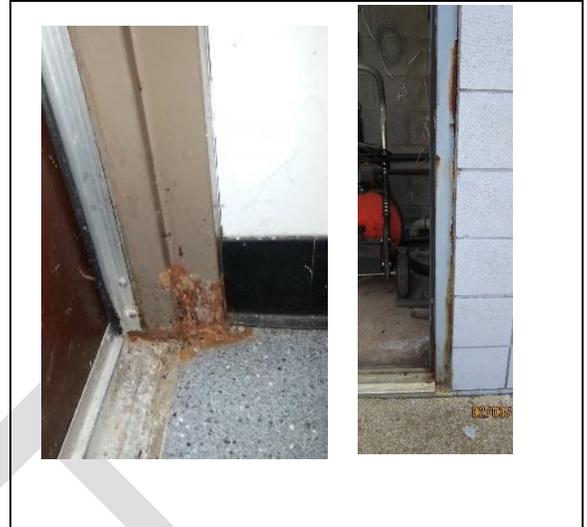
The doors are in fair condition but some have excess rust that cannot be repaired and should be replaced.

Some doors and frames are rusted making repair impossible and will need to be replaced.

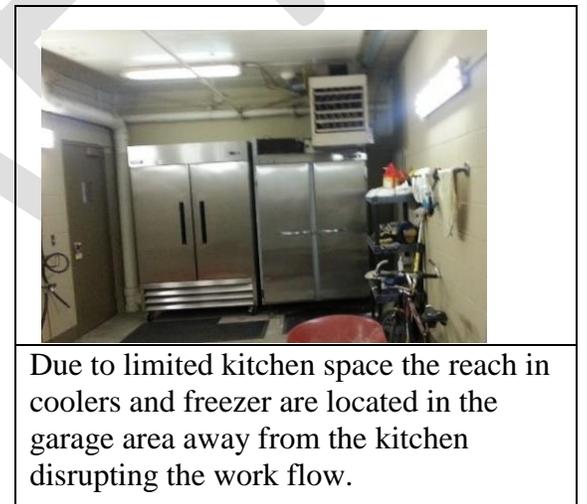
Due to limited kitchen space the reach in coolers and freezer are located in the garage area away from the kitchen disrupting the work flow.

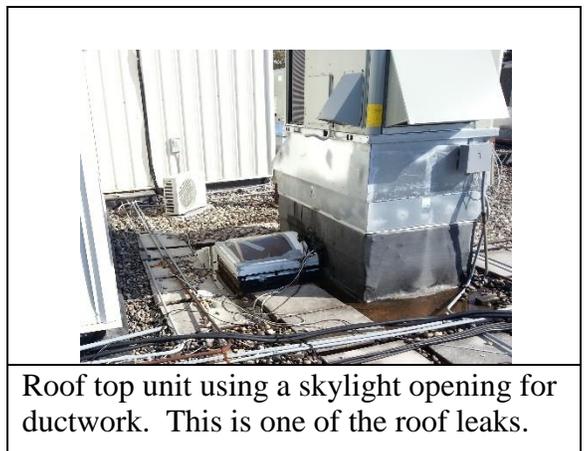
large modification (roof opening for fans, heating, air conditioning, etc.) which may explain why a skylight was replaced with a roof top unit. This is one of the areas that is leaking. In addition the planks in many areas are exposed (no dropped ceiling due to limited space) and all wiring and piping that has been added over the years is exposed. This includes the inmate areas.

Roof top unit using a skylight opening for ductwork. This is one of the roof leaks.

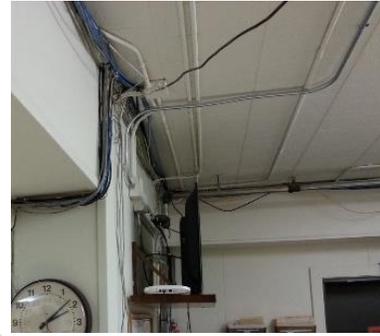
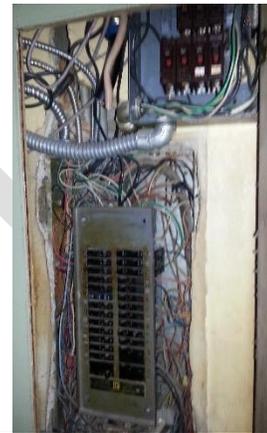
Electrical and wiring has been added over the years for computers and system added to the buildings. Many of the electrical panels have been rewired to accommodate the ever increasing computers and other devices that require communication or power.

Power and communication wiring has greatly increased since the building was built in 1962. With a hard concrete ceiling in most of the building most of the wire is exposed. In some central areas (near the server room) the amount of wiring and cable is causing the drop in ceiling to crack.

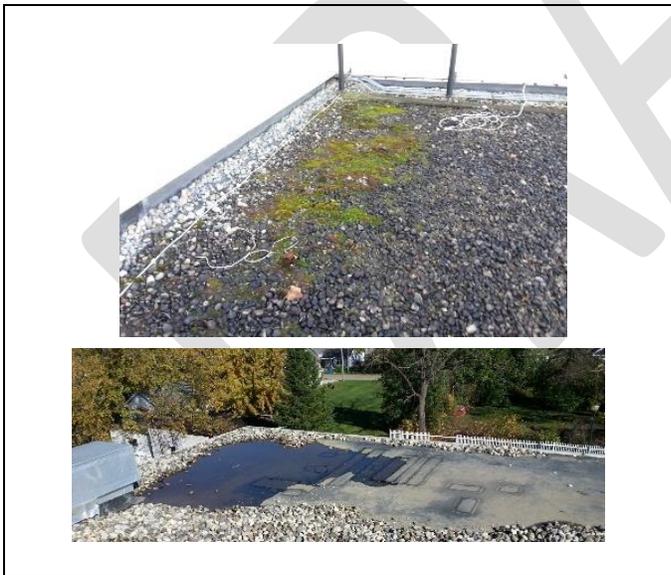
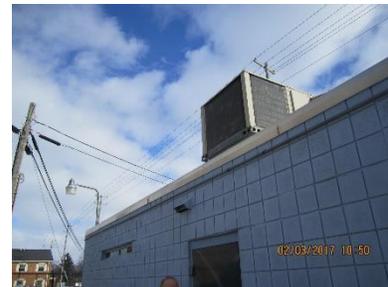
Several roof top units are within 10 feet of the edge of the roof. Per code these units need a protective barrier to prevent accidents.

The roof is estimated to have been installed in the 1980's. It is a ballasted (rocks) membrane roof. Overall in poor condition with standing water, numerous areas where rocks have been removed and not replaced. Several roof drains need to be cleaned and the lint on the roof below the dryer vents should be regularly cleaned.

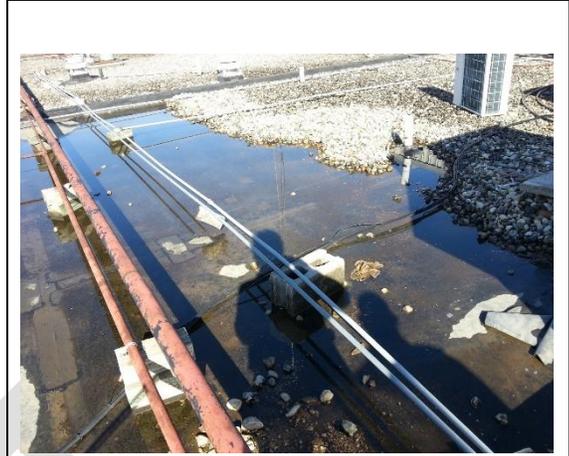
- The roof was installed in the 1980's and is over 30 years old. The Service Life of a roof is 25 to 30 years.
- The roof is poor condition with reports of leaks, areas where stones have been moved to repair leaks and not returned, standing water and algae.

As described in the Existing Condition Section above the roof should be replaced. The above picture shows standing water on the bare roof where the ballasted stones have been removed, most likely to repair a leak.

- Move existing rock ballast. Ballast will be reused
- Remove existing membrane and dispose of.
- Replace wet or damaged insulation.
- Replace damaged roof drains.
- Install new membrane roof.
- Install ballast (rocks) and add rocks as required.

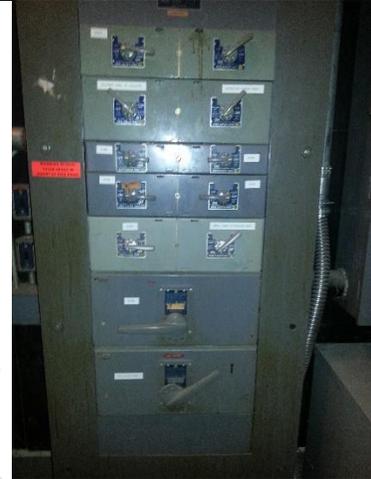
- The power factor for the building in some months is below the required power factor as required by Consumer Energy.
- The power factor is low on the Jail meter.
- Consumers Energy has a penalty charge for low power factor.

The building has a low power factor and the utility company charges a penalty for not meeting the required power factor.

- Investigate the cause of the low power factor including further review of electrical power and possible monitoring.
- Install power factor correction capacitors to increase the power factor.

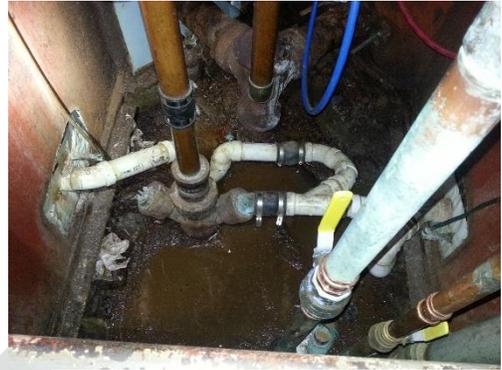
The top picture shows moisture in the piping chase between the fixtures. The constant presence of moisture due to a leak or high water table is a breeding ground for mold.

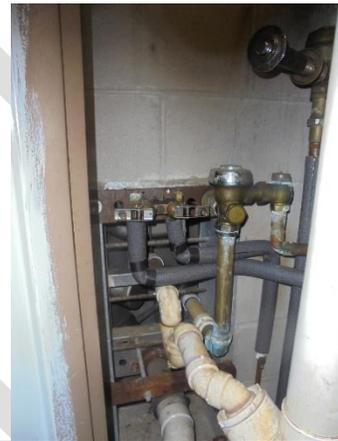
- Many of the existing cell plumbing fixtures are original high flow (gpm) fixtures
- Some of the plumbing chases are wet due to leaks.
- The existing mechanical fixtures have a pushbutton for the water closet and the sink with no limits on how often the button can be pressed.
- The correctional officers have no control over the water usage and cannot prevent water closets from being flushed (before a search or to prevent deliberate overflow of a fixture due to clogging.)

The lower picture shows a typical piping arrangement behind each cell water closet/sink combination. Much of the system is mechanical push button and inmates can press the buttons (flush and faucet) as often as they want.

- Remove the existing mechanical system.
- Install an electronic system that will save water through programmed flow.
- The existing fixtures will be reused.
- The electronic system will can be controlled for a computer by the correctional officers to limit the amount of flushes and shut off the water to the cells.

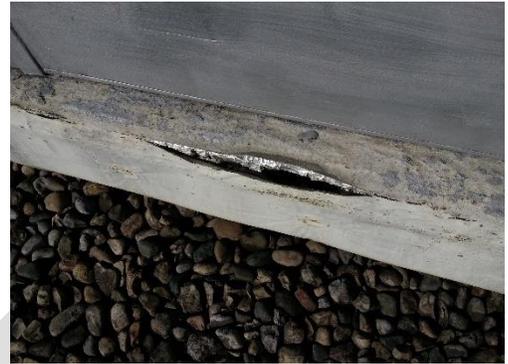
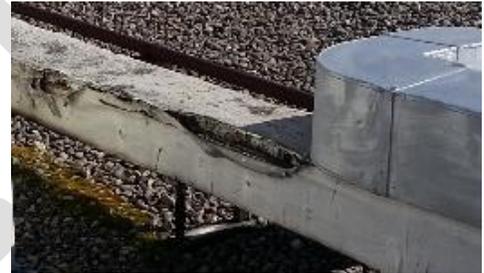
- Some of the roof top unit (RTU) for heating and air conditioning have insulated ductwork on the roof expose.
- The insulation covering in places has split open allowing moisture to penetrate the insulation and ductwork. The moisture will eventually soak the insulation and rust the ductwork.

Some of the roof top units providing heating and air conditioning have ductwork on the roof. In several areas the insulation is cracked allowing moisture to penetrate. The insulation and duct should be repaired and sealed.

- Repair or replace insulation or ductwork as required.

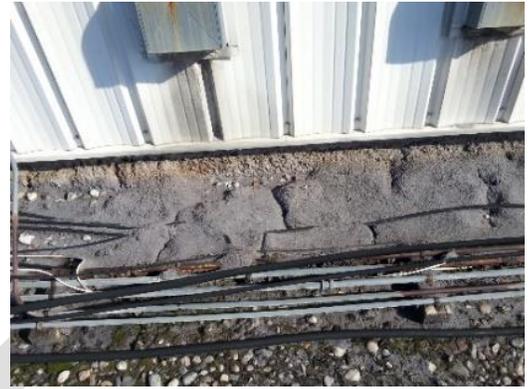
- The dryers vent directly onto the roof along a wall that does not receive adequate air circulation (cut off from the wind.)
- If the roof is not cleaned regularly the lint collects on the roof presenting a fire hazard.

The above shows a collection of lint from dryers behind the adjacent wall. The lint collects on the roof. We propose to raise the vents above the roof line for a better dispersion.

- Redirect the dryer vents up through the roof or out the existing opening and over the roof a sufficient distance to increase dispersion.
- Investigate improved lint collection system.

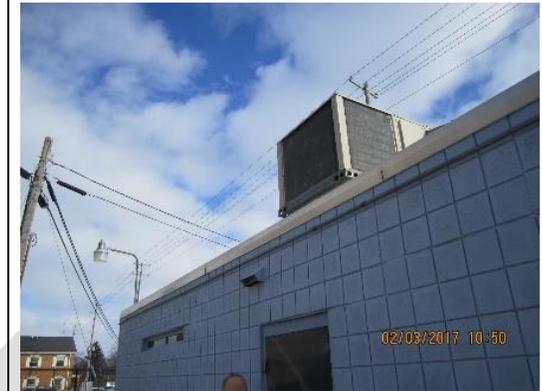
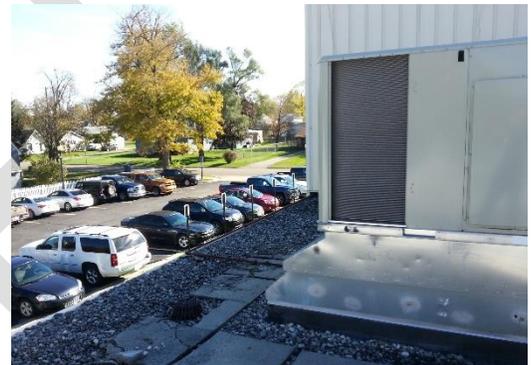
- Per code all equipment should be 10 feet from the edge of a roof or a barrier needs to be erected.
- (2) Roof top units are within 10 feet of the edge of the roof presenting a fall hazard.

1012.5 Mechanical equipment. Guards shall be provided where appliances, equipment, fans or other components that require service are located within 10 feet (3048 mm) of a roof edge or open side of a walking surface and such edge or open side is located more than 30 inches (762 mm) above the floor, roof or grade below. The guard shall be constructed so as to prevent the passage of a 21-inch-diameter (533 mm) sphere.

The above roof top units are within 10 feet of the edge of the roof. A barrier need to be erected near the unit to prevent accidents.

- Install a roofing barrier near the equipment per code.

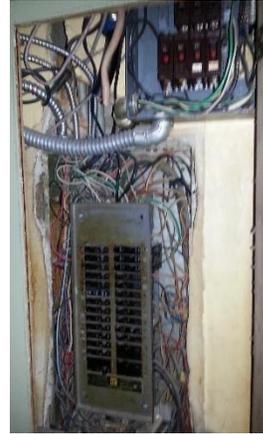
- The main building was installed in 1962.
- Over time additional electrical equipment and computers have come into everyday use.
- The building was never designed for the equipment needed to operate a modern buildings.
- Electrical panels have been added and expanded on and are in need of replacement, rewiring and consolidation.

Over the years since 1962 additional electrical equipment and computers have been added to existing electrical panels or electrical panels have been added as required. Some of the panels have become overloaded and need to be replaced and rewired.

- Review electrical panels and loads on the panels.
- Install new panels and consolidate where possible
