PRELIMINARY REPORT

SHIAWASSEE COUNTY JAIL

Facility Study

January, 2018

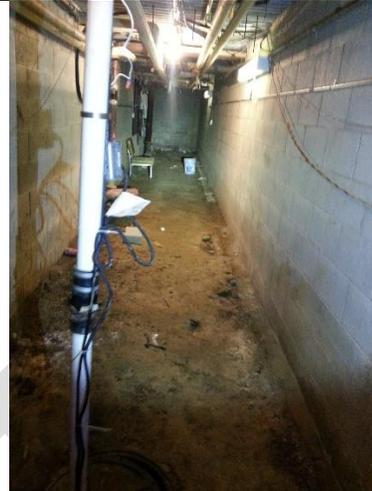
The piping tunnel is a dirt floor with signs of moisture from the ground and dripping moisture from above. The tunnel allows access to the mechanical and electrical room.

The top picture shows the access tunnel (domestic hot and cold water, gas, electrical) below portions of the jail. The space has a sand floor with signs of moisture on the walls.

The lower picture shows the deteriorating insulation, piping and wiring in the tunnel.

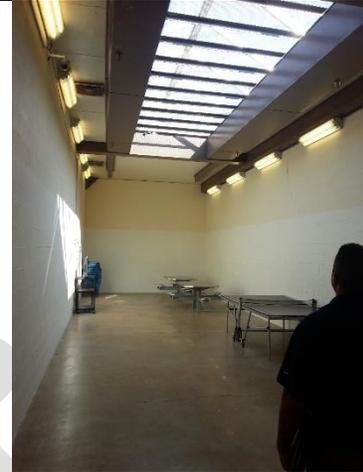
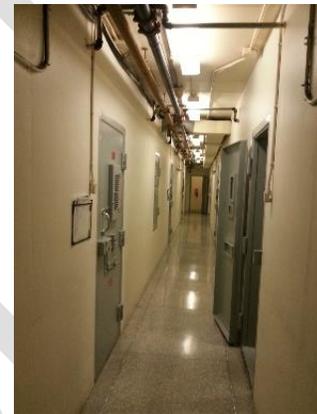
Most of the lighting is 32 watt T8 and electronic ballasts. As part of this Energy Conservation Measure all of the fluorescent fixtures will be replaced or the lamps will be replaced with LED saving energy. LED's will have a 5 to 7 year warranty.

Occupancy sensors will be added in applicable areas to meet the 2018 Michigan Energy Code.

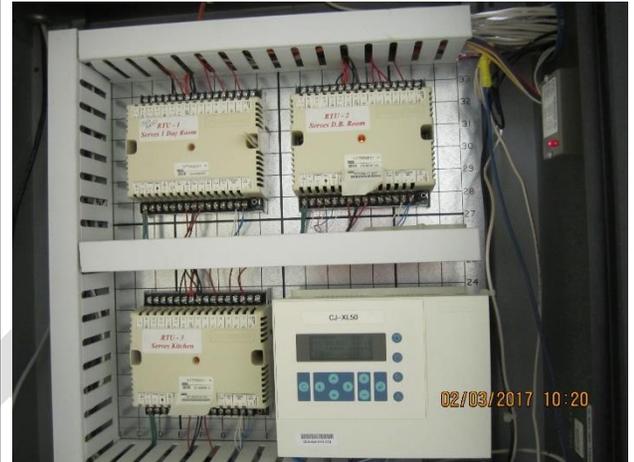
The existing control system is fairly extensive and in good condition. The County Jail Personnel have limited access to the system. This Energy Conservation Measure will give further access. Temperature control retrofits will help but not alleviate the problems with the lack of proper temperature control zoning in the building.
